CITY WIDE BUILDING & FACILITIES CONDITION
ASSESSMENT CIP 13-664
FOR THE CITY OF HERMOSA BEACH

Prepared by:
CivilSource, Inc.
July 2015
9890 Irvine Center Drive
Irvine, CA 92618
P: 949-585-0477
F: 949-585-0433
civil-source.com

**City Hall
1315 Valley Drive
Hermosa Beach, California
Condition Assessment Survey
July 9, 2015**

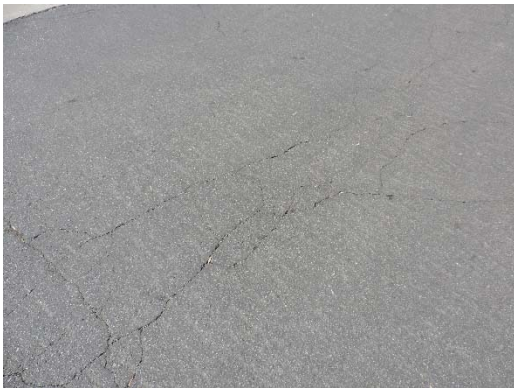
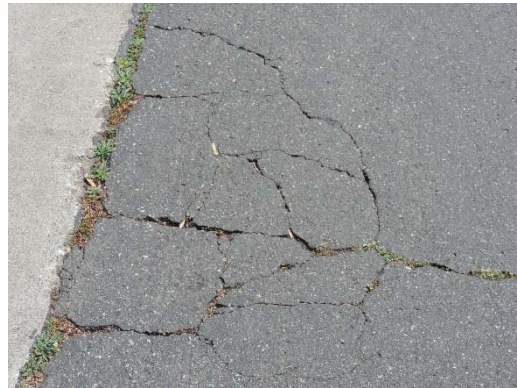
Asphalt is in poor condition with many cracks, weeds growing through cracks, and no sealer. Recommendations: 1. Remove weeds and apply weed killer 2. Seal and patch cracks 3. Remove and replace worse cracked areas by swale. 4. Slurry seal 5. Stripe.

1.1	Driveways	Asphalt	See comments on asphalt for parking lot item 1.2									
1.2	Parking lot	Asphalt	Asphalt is in poor condition with many cracks, weeds growing through cracks, and no sealer.	1. Remove weeds and apply weed killer 2. Seal and patch cracks 3. Remove and replace worse cracked areas by swale 4. Slurry seal 5. Stripe				\$15,000

1.2.1	Parking lot	Asphalt	Asphalt is in poor condition with many cracks, weeds growing through cracks, and no sealer.	Remove and replace entire parking area, seal and stripe.	16000	sf	\$4				\$64,000

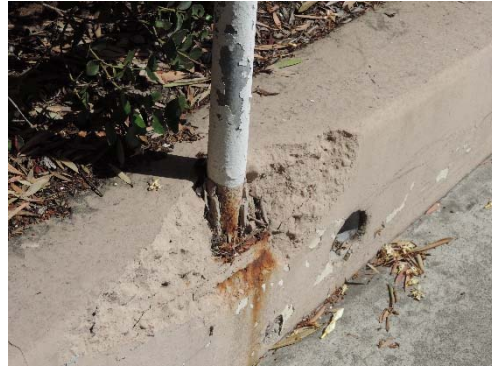
Retaining walls and railing In the front parking lot the retaining walls are in generally good condition with no signs of defects or cracks. The public works parking lot has concrete spaling which requires patching. Recommend patch concrete at handrails in the public works parking area. Then repaint handrails.

1.11	Retaining walls	Concrete	In the front parking lot the retaining walls are in generally good condition with no signs of defects or cracks. The public works parking lot has concrete spalling which requires patching	Patch concrete at handrails in the public works parking area.				\$5,000

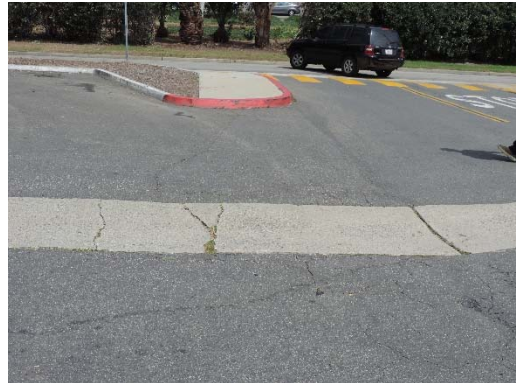
Swales/gutter Concrete swale is old and cracked but is generally functional. Recommend replacing when parking lot is replaced.

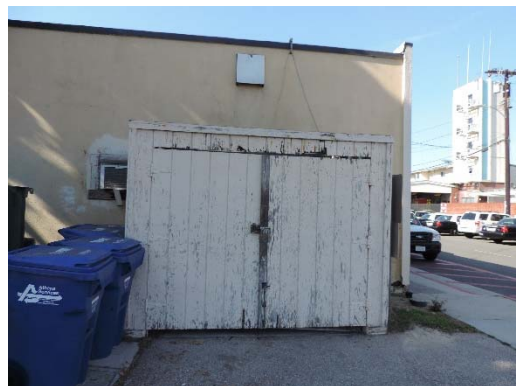
Trash enclosure The wood trash enclosure in the back parking lot is in very poor condition. Recommend replace with masonry trash enclosure and metal gates.

1.14	Trash enclosure	Wood enclosure	Condition is very poor	Recommend replace with Masonry trash enclosure and metal gates				\$7,000				
1.15	Flagpoles	Steel	Generally in good shape with no signs of defects	None								
	Subtotal							\$41,500	\$0	\$69,000	\$3,000	
2	Site utilities

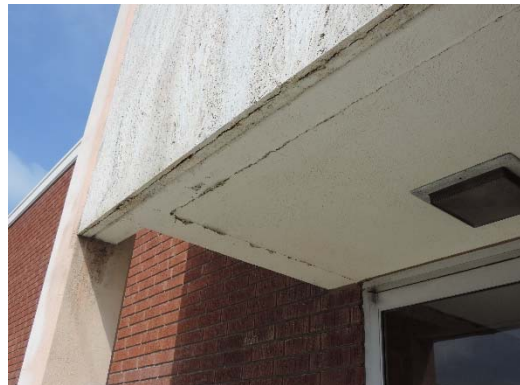
Exterior walls/back (West) Observed separation at bottom of decorative stone, paint is peeling at joint. Recommend seal and repaint.

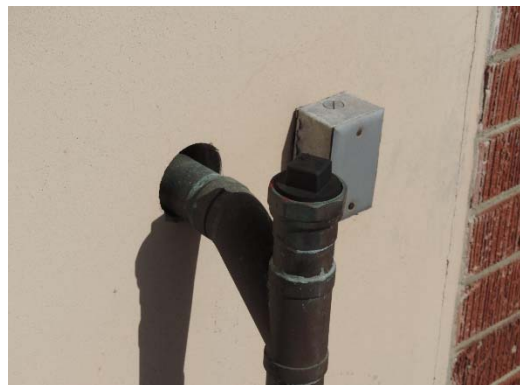
Exterior walls/back (West) Observed water main penetration into wall is not sealed. Wide gap between pipe and concrete core which allows water to infiltrate into building. Recommend caulk and seal to prevent water leaks during rain.

4.1.3	Exterior walls/back (West)	Decorative stone	Separation at bottom, paint is peeling at joint	Seal and repaint	1	ls		\$2,000			
	Exterior walls/back (West)	Water Main penetration into wall	Wide gap between pipe and concrete core which allows water to infiltrate	Caulk and seal to prevent water leaks during rain	1	ls		\$150

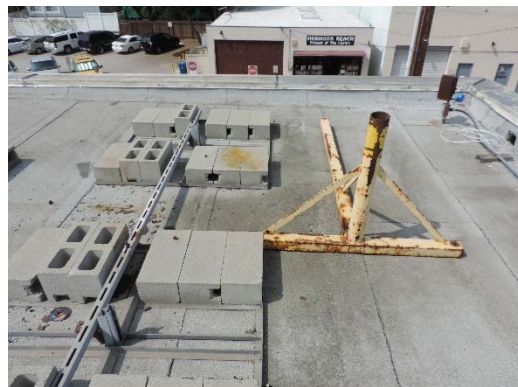
Roofing material Observed the flat Built-up asphalt roofing is in fair condition. Generally clean with no bubbles, no tears, and no visible defects. Some ponding in isolated areas. Follow general maintenance procedures. Recommend remove debris and general clean up.

5.1	Roofing material	Flat Built-up asphalt roofing	Fair condition. Generally clean with no bubbles, no tears, and no visible defects. Some ponding in isolated areas.	Follow general maintenance procedures. Remove debris and general clean up.				\$250

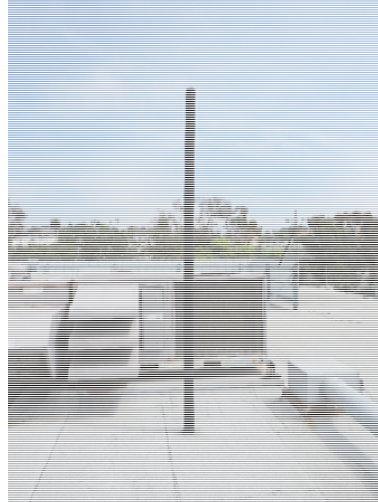
Generally installed correctly, caulking is good but needs maintenance. One sewer vent line is unsupported and has moisture around the penetration in the roofing. Requires lateral support and caulking at the penetration.

5.2	Penetrations and projections	Pipe send vents	Generally installed correctly, caulking is good but needs maintenance.	One sewer vent line is unsupported and has moisture around the penetration in the roofing. Requires lateral support and caulking at the penetration.	1	ls		\$500

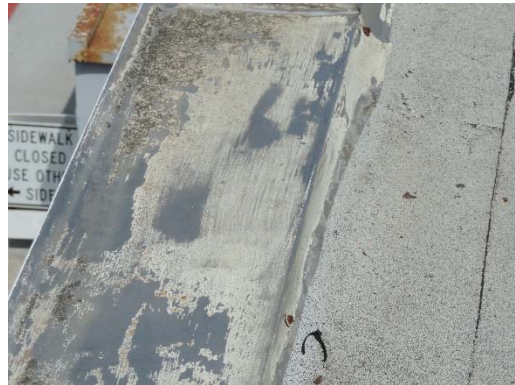
Flashing Old but seems free of defects. Recommend provide routine maintenance by cleaning and replacing caulking every 4-6 years.

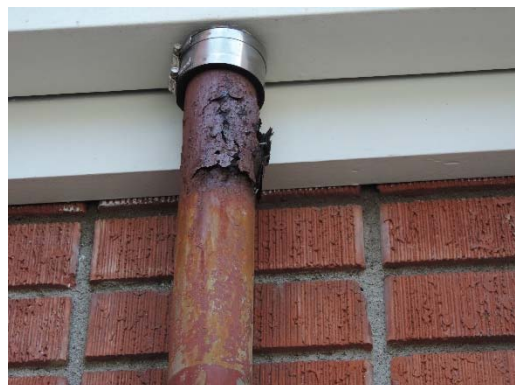
Downspouts Solid and securely attached to exterior walls, no signs of leaks or defects. Except one on the south side. Recommend clean, repair, and repaint one downspouts identified in photo.

5.8	Downspouts	Metal	Solid and securely attached to exterior walls, no signs of leaks or defects. Except one on the south side.	Clean, repair, and repaint one downspouts identified in photo				\$500

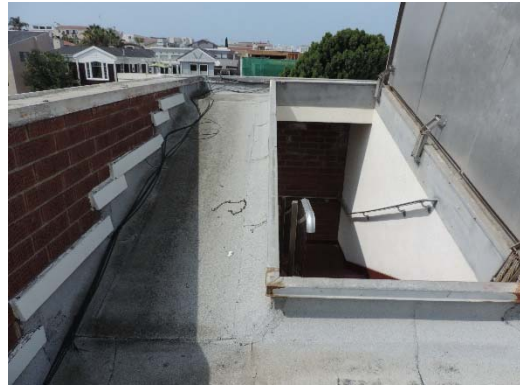
Roof hatch Observed roof access hatch is rusted on edges, old but functional, it lets daylight when closed (it may leak during rains). Recommend replace in the next five years.

5.9	Roof hatch	Metal	Rusted on edges, Old but functional, let's daylight when closed (it may leak during rains)	Replace in the next five years. Low priority.	1	ls	\$1,500		\$1,500		
	Subtotal							\$4,750	\$1,500	\$0	\$51,254
6	Building interiors- basement

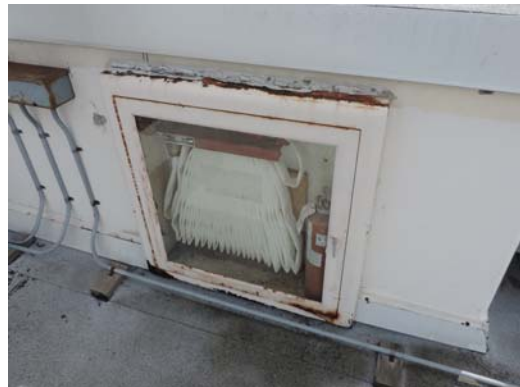
Fire Hose Cabinet Observed fire hose cabinet has rusted beyond repair. Recommend replacing the cabinet with a new one.

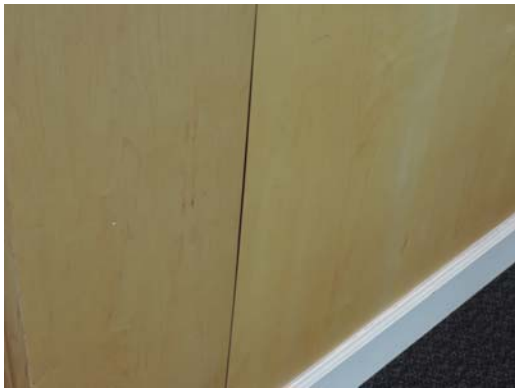
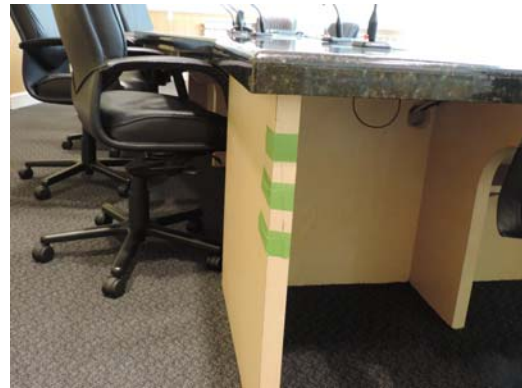
The Council chamber is generally in fair condition. The millwork and wood paneling plastic laminate in many areas is peeling away and delaminating. Recommend repair as necessary.

6.11	Chambers cabinetry	plastic laminate panels and counters	Plastic laminate is peeling off of the millwork in many areas. Repair as required.	Repair as required.	1	ls	\$5,000	\$5,000			
	Subtotal							\$18,150

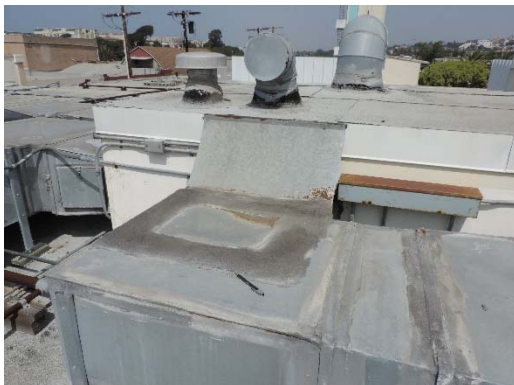
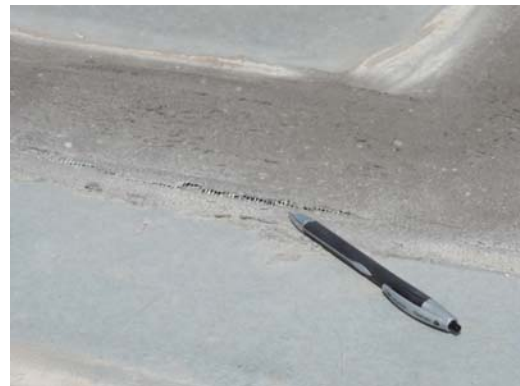
1. **Ducting** Galvanized sheet metal is in poor condition, with joints separating and caulking; all joints need to be caulked and repaired now. Consider replacing in the near future.
